# Manhole Inspection Summary

Manhole # S27CC\_014MH

Insp Date: **11/15/07 3:20 PM**

**Location** Address: **1514 ARGYLE AVE**

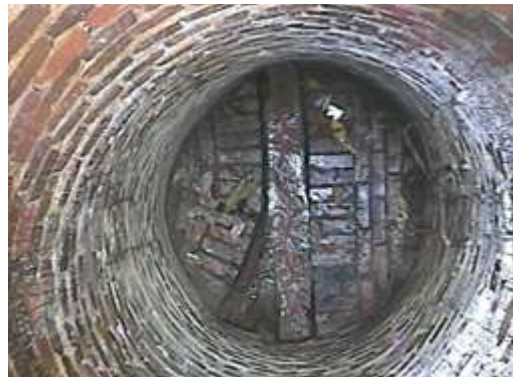
Defect 1

Count: **6** Missing: **0** ☒ **Corroded**

STEPS CORRODED

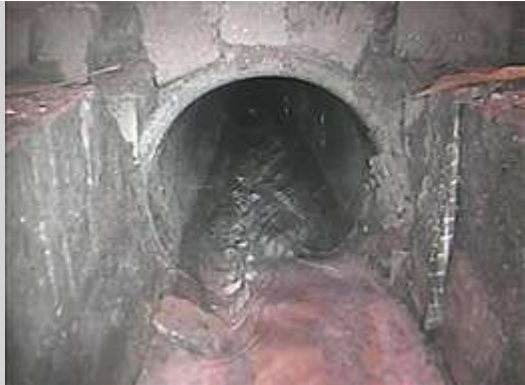
12 O'Clock Outflow

8 in. Circular Gravity Sewer  
Pipe Out @ 12 O'Clock

Pipe Height: (in.) Direct  
Pipe Material: **Clay** ☐ Pipe Lined  
Invert Depth: **9.60** (ft.) Flow Characteristics: **Slow**  
Deposits: ☒ None ☐ Mud ☐ Sludge ☐ **Debris** ☐ Grease  
Silt Depth: (in.) Deposits Extent:  
Infiltration: **None** Pipe Seal Cond: **Sound**

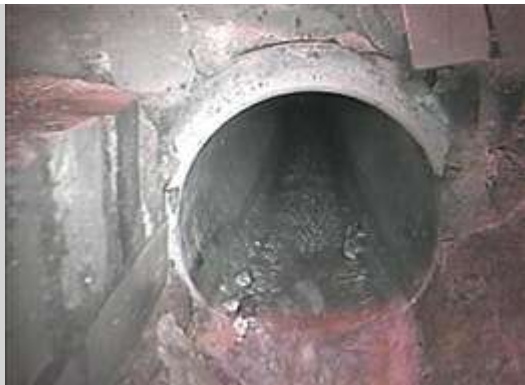
6 O'Clock Inflow

8 in. Circular Gravity Sewer  
Pipe In @ 6 O'Clock

Pipe Height: (in.) Direct  
Pipe Material: **Clay** ☐ Pipe Lined  
Invert Depth: **9.54** (ft.) Flow Characteristics: **Slow**  
Deposits: ☒ None ☐ Mud ☐ Sludge ☐ **Debris** ☐ Grease  
Silt Depth: (in.) Deposits Extent:  
Infiltration: **None** Pipe Seal Cond: **Sound**

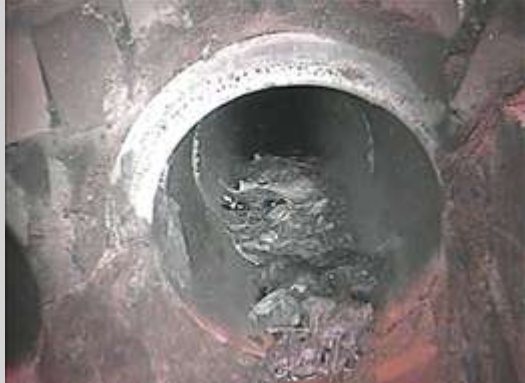
7 O'Clock Inflow

Pipe In @ 7 O'Clock

Deposits: ☐ None ☐ Mud ☐ Sludge ☒ **Debris** ☐ Grease

Silt Depth: **1** (in.) Deposits Extent: **Light**
